ASPHALT REPLACEMENT AT CAJON PARK SCHOOL

SANTEE SCHOOL DISTRICT

June 20, 2019
Project No. 108828001

Subject: Geotechnical Pavement Evaluation
Cajon Park School Hardcourt Pavement
10300 North Magnolia Avenue
Santee, California

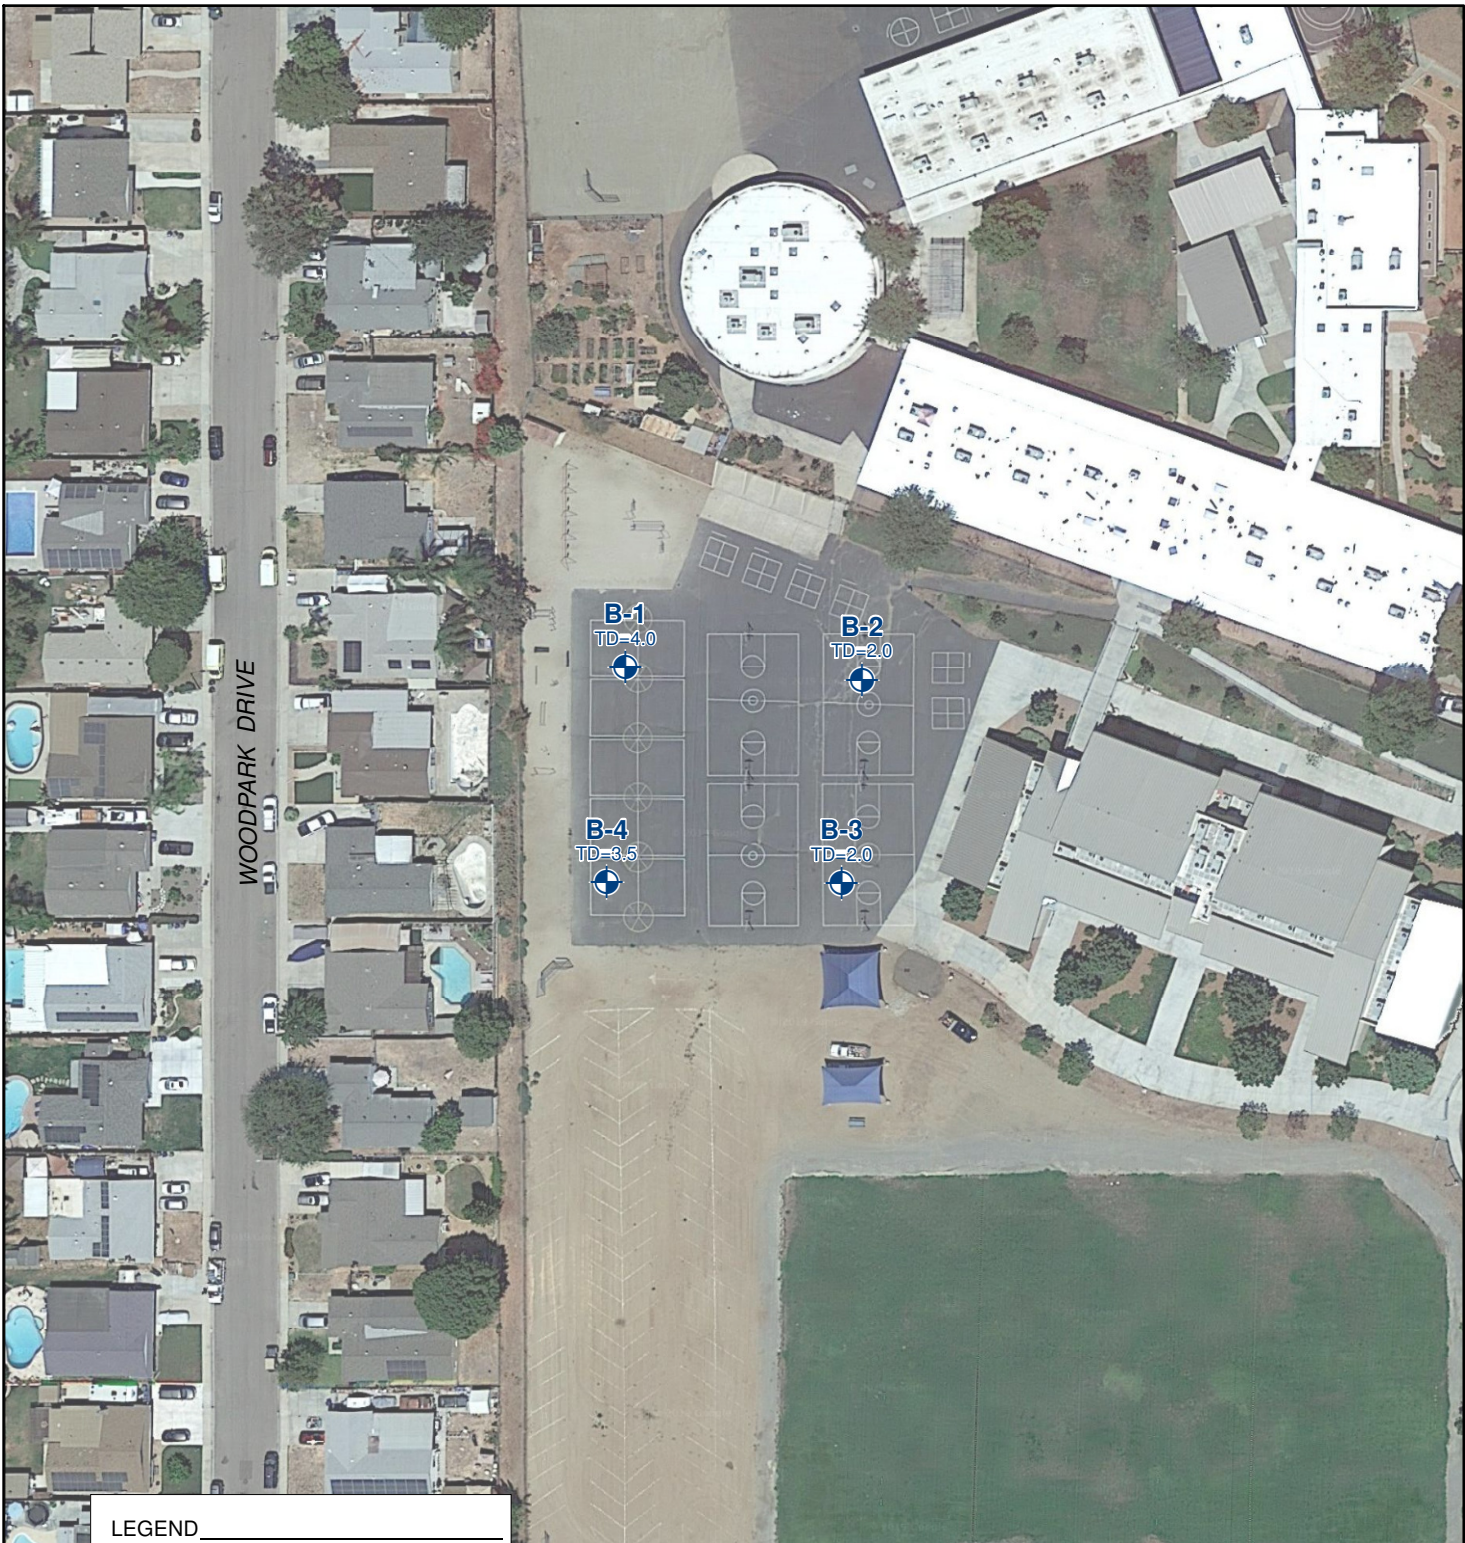
FIGURE 2

- The western side of the existing AC paved hardcourt (i.e., near borings B-1 and B-4) is underlain and supported on fill materials while the eastern side (i.e., near borings B-2 and B-3) is underlain and supported by a thin fill layer over granitic rock.
- The fill materials underlying the play area are clayey in nature.
- Moisture conditions of the fill materials range between approximately 11 and 15 percent.
- Headers (i.e., edge confinement) were not observed along the southern, western, and northwestern sides of the play area where the AC is bounded by dirt surfacing (Photograph 5).
- Cracks previously patched have or are reopening (Photographs 1, 3, 4, and 5).

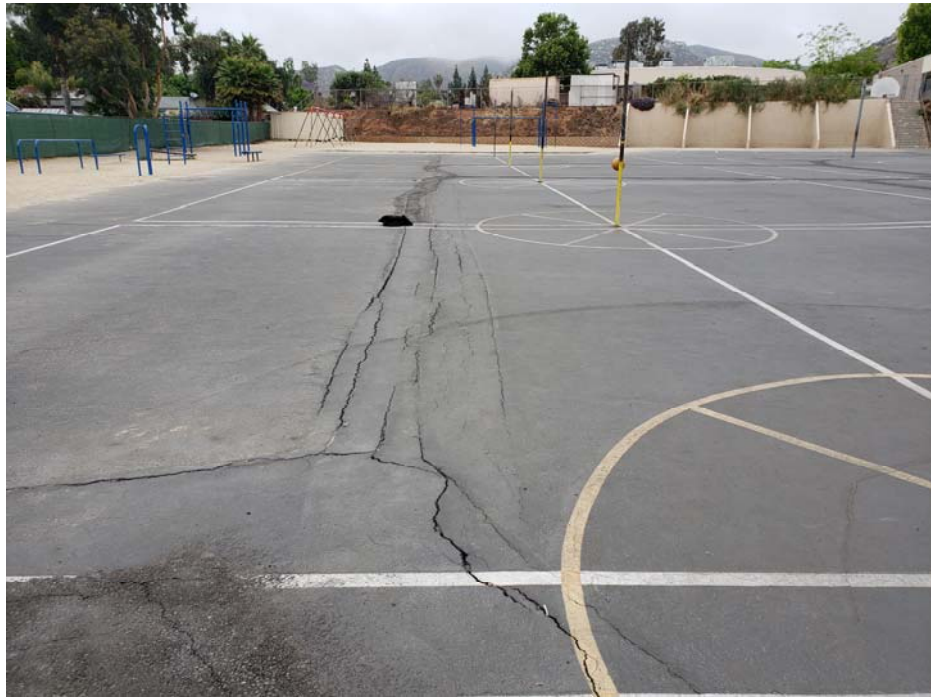
Based on our discussions with you and the observations during our May 1, 2019 site visit, the existing AC hardcourt has experienced cracking and separation at several locations. Many of those cracks had been previously sealed or repaired and the cracks continue to propagate through the patching.

Photograph 1: View of hardcourt play area looking north. Open cracks running in the north-south orientation.

Due to the variable moisture conditions and types of the subgrade materials along with the presence of Petromat[®] and crack sealants, we recommend that the AC hardcourt pavement be reconstructed. The proposed reconstruction should be performed in accordance with the recommendations provided herein and the requirements of the applicable governing agencies. Ninyo & Moore should be contacted for questions regarding the recommendations or guidelines presented herein.

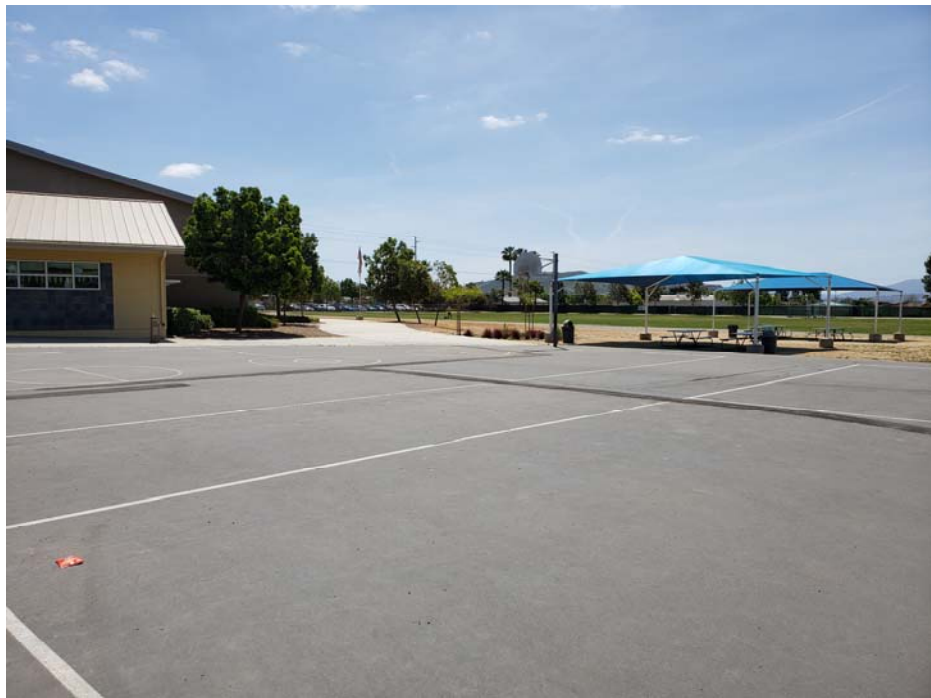
Photograph 2: View of hardcourt play area looking southeast. Patched cracks running in the north-south and east-west orientations.

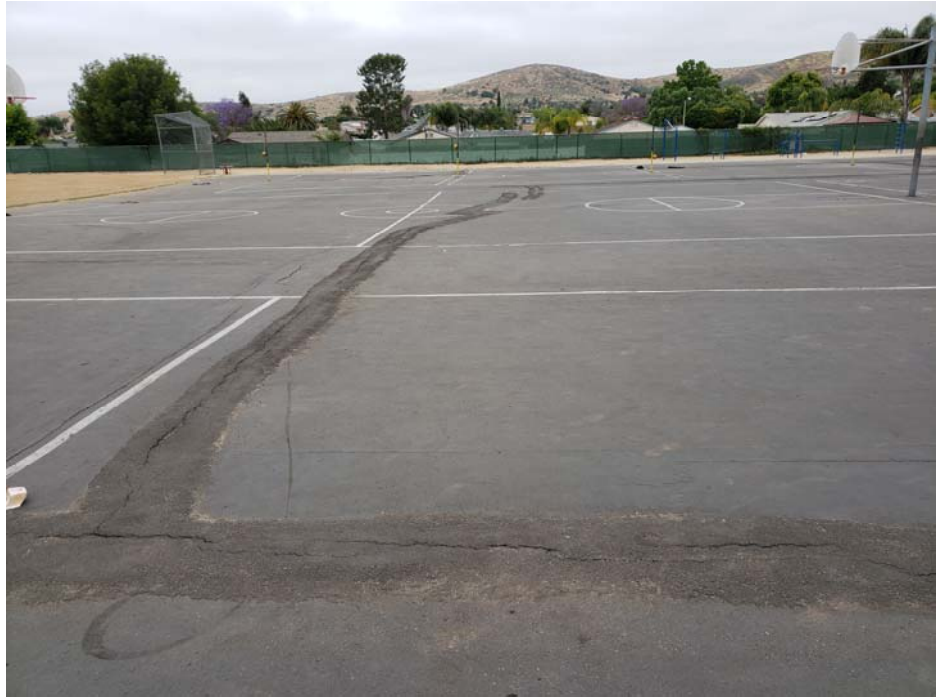
Photograph 3: View of hardcourt play area looking west. Previously patched cracks reopening.

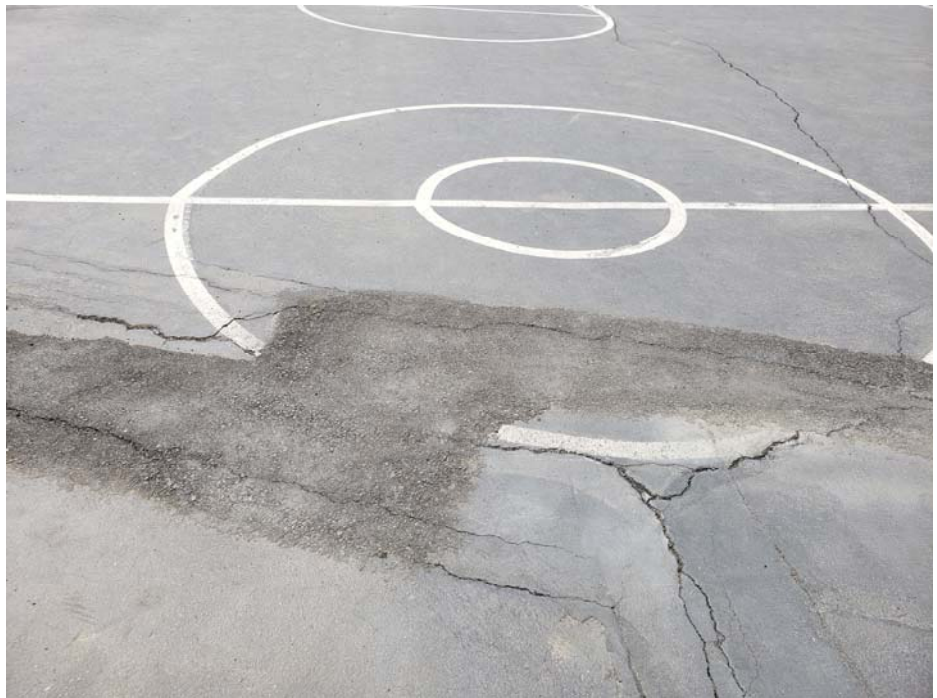
Photograph 4: Close-up view of open cracks and cracks previously patched and since reopened.

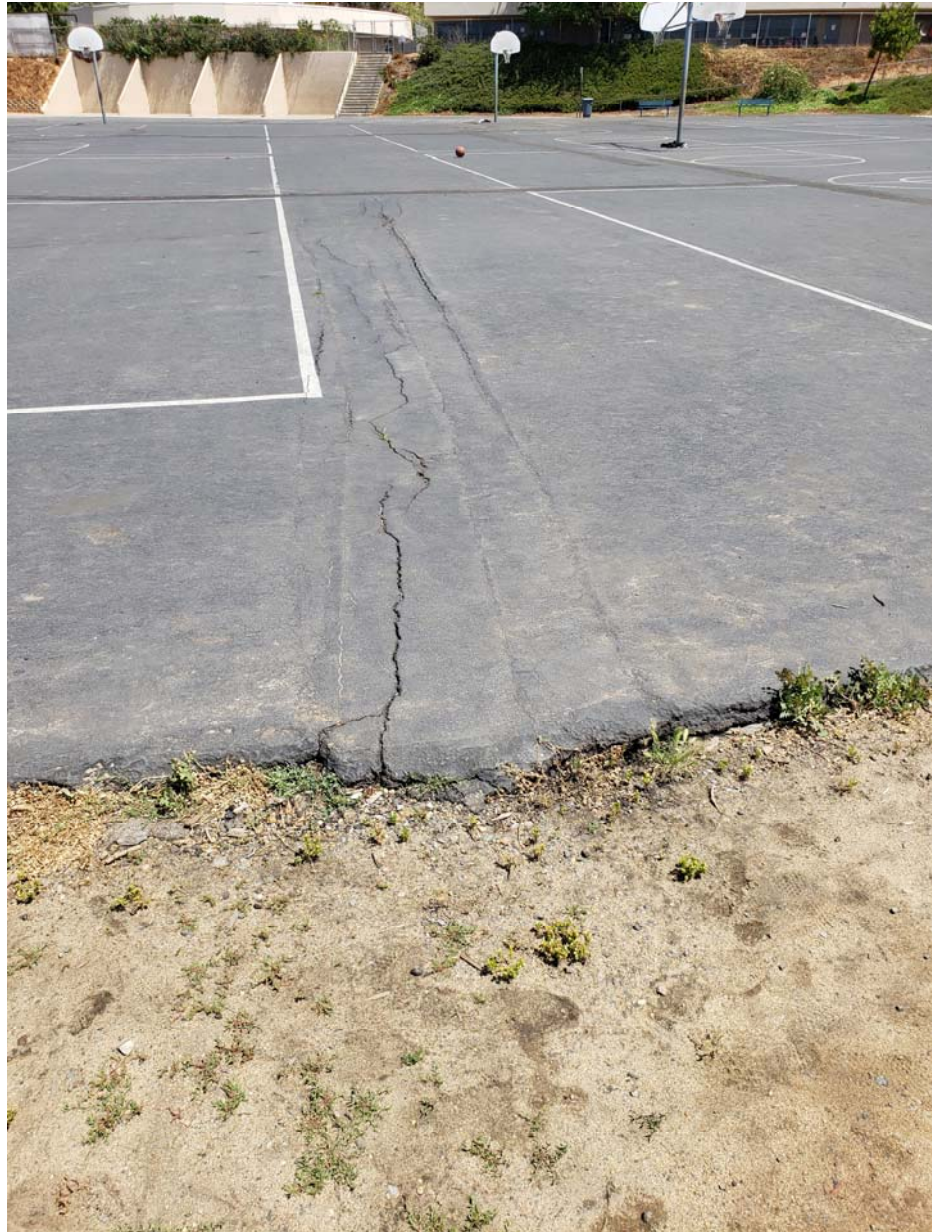
Photograph 5: View of southern edge of hardcourt play area where AC is adjacent to dirt surfacing. Pavement header (i.e., edge confinement) not present.

Headers (i.e., edge confinement) were not observed along the play area perimeter where the hardcourt surfacing abuts dirt surfacing. As part of the reconstruction, we recommend that continuous headers be utilized along the portions of the play area perimeter which are adjacent to the dirt surfacing. Also, the AC surface should be placed in such a manner to provide positive drainage so that surface water is not permitted to pond on the surface and is diverted off of and away from the AC materials.
