February 26, 2021
Project No. 109188001

Subject: Geotechnical Pavement Evaluation
Pride Academy at Prospect Avenue School Hardcourt Pavement
9303 Prospect Avenue
Santee, California

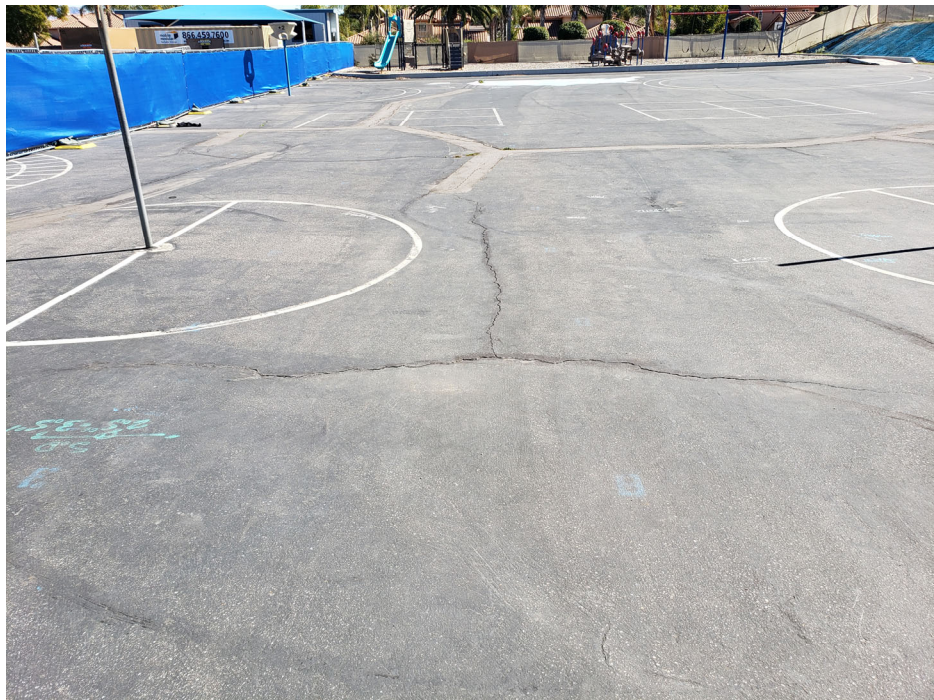
Based on our discussions with you and the observations during our February 15 and 18, 2021 site visits, the existing AC hardcourt areas have experienced cracking and separation at several locations. Many of those cracks had been previously sealed or repaired and the cracks continue to propagate through the patching.

Photograph 2: North Hardcourt: View of play area looking east. Open cracks and previously patched cracks.

Due to the variable moisture conditions and types of the subgrade soils beneath the existing AC pavements, along with the presence of paving fabrics and crack sealants, we recommend that the AC hardcourt pavement be reconstructed. The proposed reconstruction should be performed in accordance with the recommendations provided herein and the requirements of the applicable governing agencies. Ninyo & Moore should be contacted for questions regarding the recommendations or guidelines presented herein.

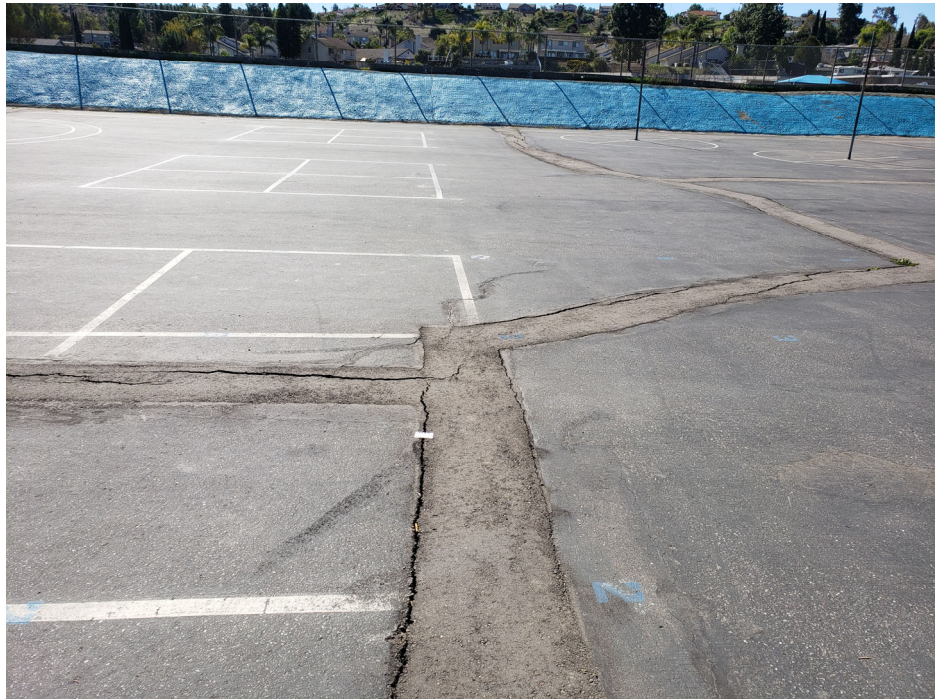
Photograph 3: North Hardcourt: View of play area looking south. Previously patched cracks reopening.

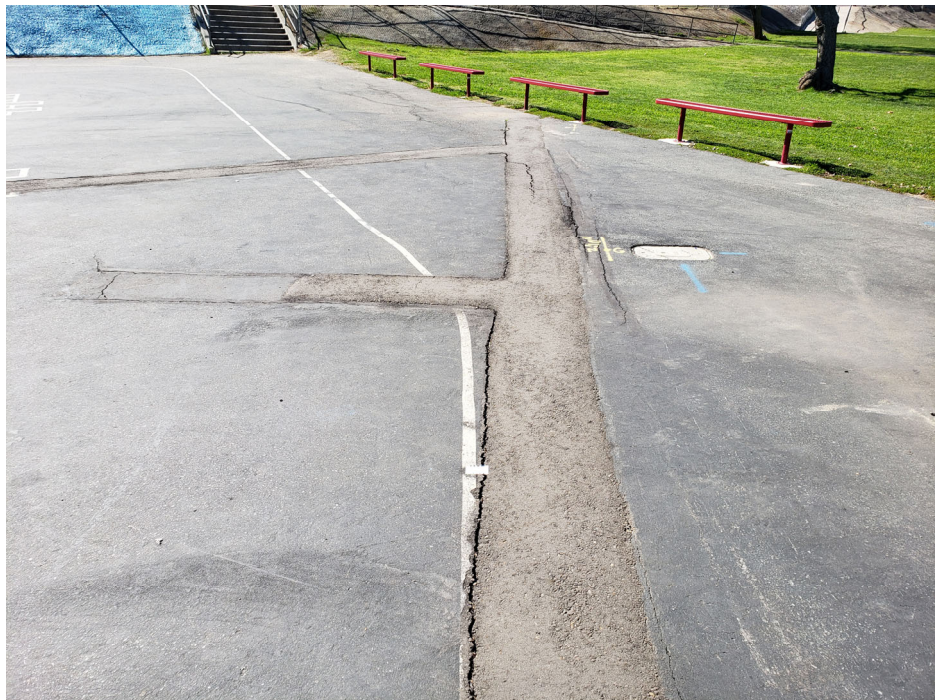
Photograph 4: North Hardcourt: View of play area looking west. Previously patched cracks reopening.

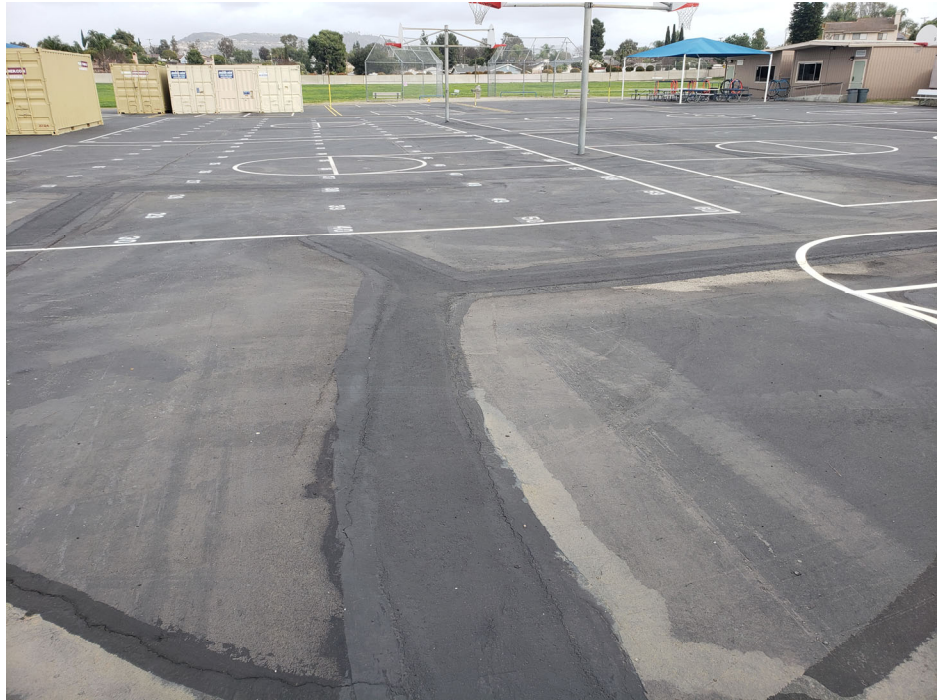
Photograph 5: West Hardcourt: Overall view of play area looking east. Open cracks and previously patched cracks.

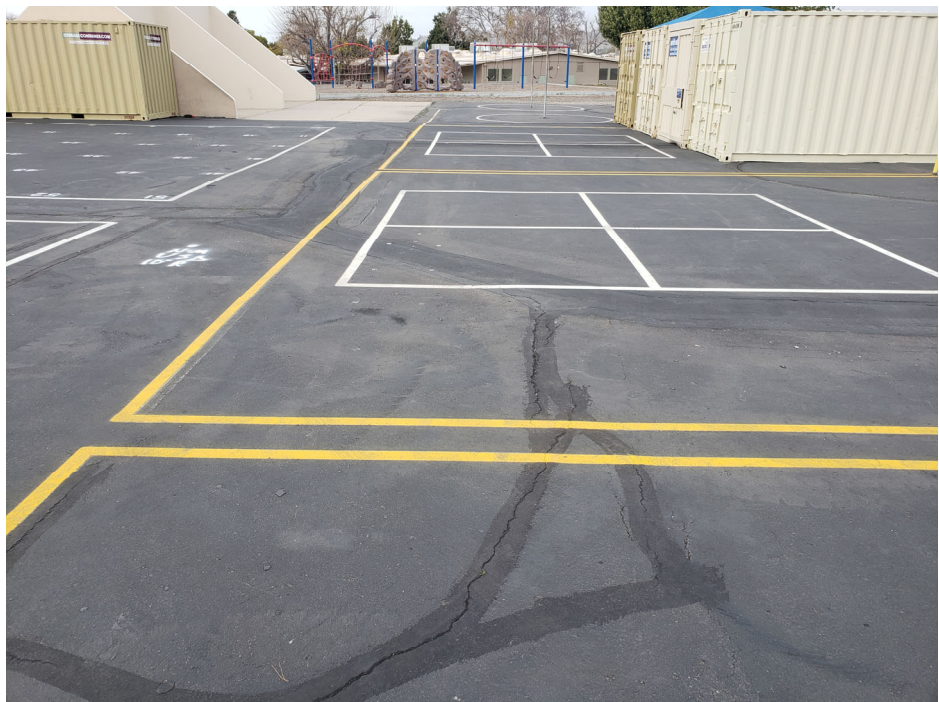
Photograph 6: West Hardcourt: View of play area looking north. Open cracks and previously patched cracks.

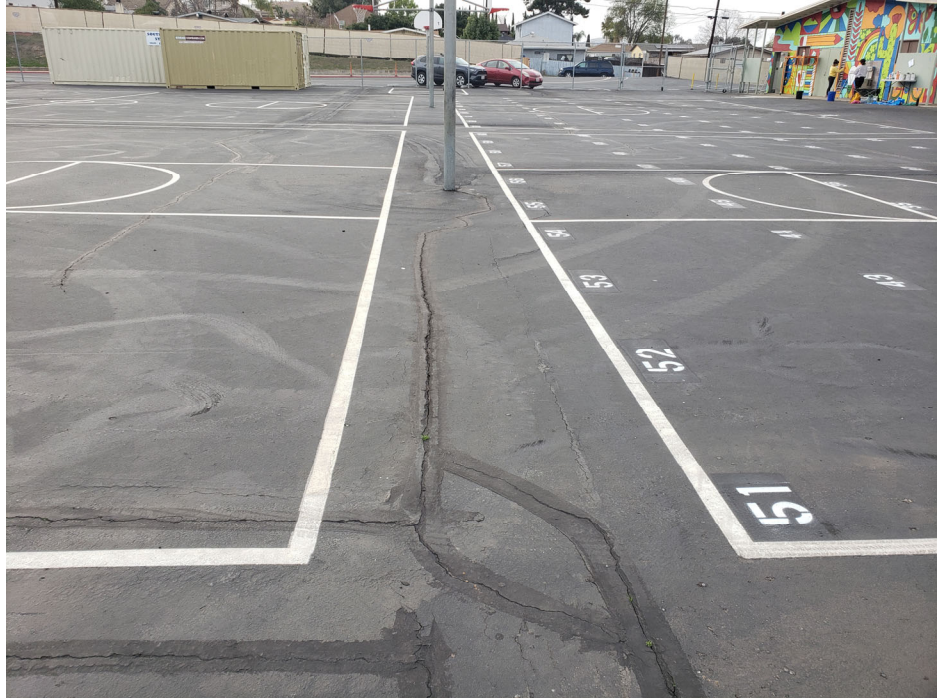
Photograph 7: West Hardcourt: View of play area looking west. Open cracks and previously patched cracks.

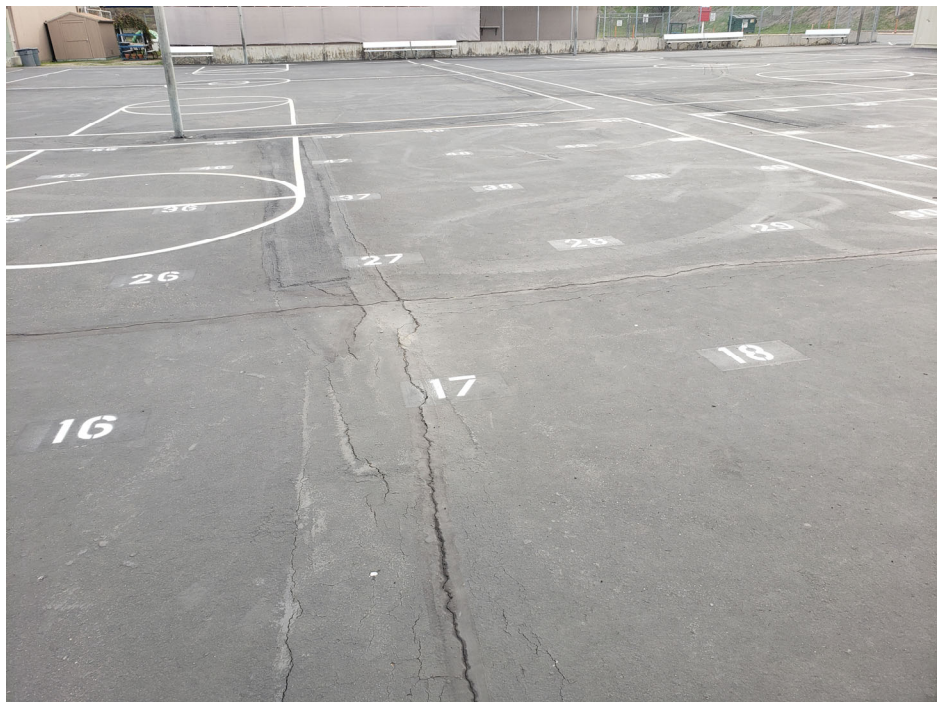
Photograph 8: West Hardcourt: View of play area looking south. Open cracks and previously patched cracks reopening.
